A case of shadow flicker/flashings: assessment and solution

A D CLARKE,
Techno Policy Group, Open University, Walton Hall, Milton Keynes, UK

A short study was carried out investigating a reported problem of shadow flicker and flashing from the blades of a turbine. The incidence of this phenomenon was confirmed and the duration and frequency of occurrence assessed. The shadow flicker period would be short and only occur at certain times, but could cause irritation. A device to stop the turbine when shadow flicker occurred was recommended and is described. A recommendation was made that turbines should be sited at least ten diameters distance from habitations, and more if sited to the East/Southeast or West/Southwest, and the shadow path identified.

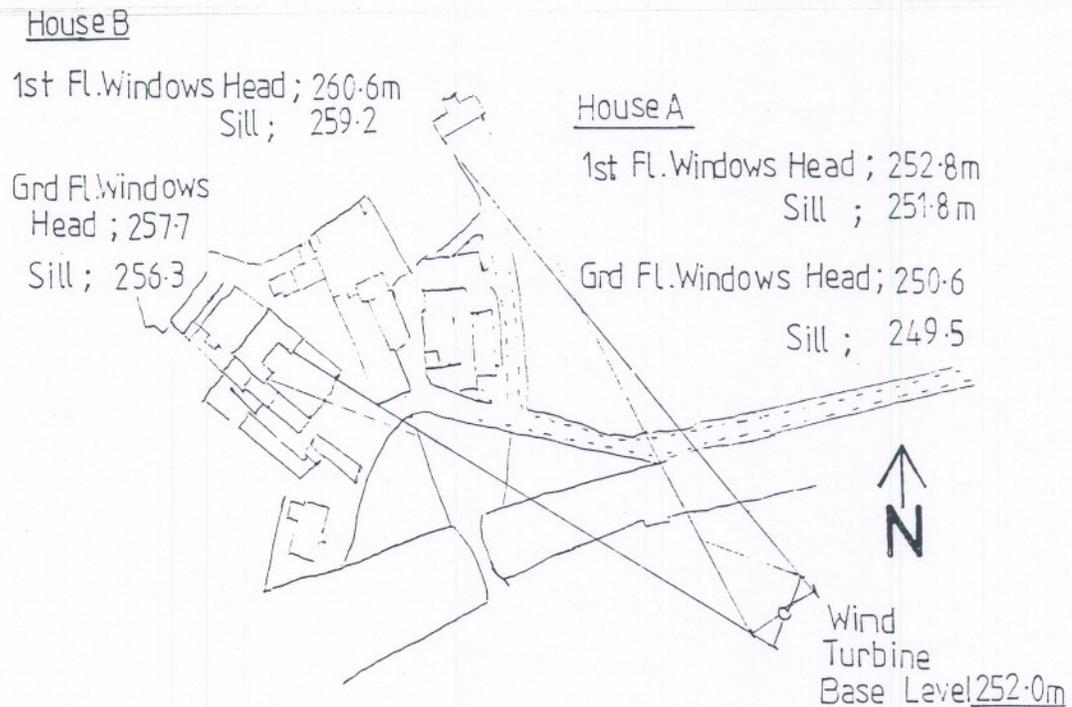
It was found that the orientation range of the turbine to house A when blades were facing or perpendicular was 142-154 degrees SE. The range of angle of elevation from house A to the turbine blades was 5.2-13.9 degrees.

In the case of house B, the orientation range to the turbine with blades facing the building was 123-112 degrees ESE.

Clearly the turbine in this case does not conform to this general guideline, and this must contribute to the problem here, as well as the siting South East of the houses. The turbine is 7.36 diameters from the house, almost 3/4 of the recommended distance.

Fig 1 Plan of houses and turbine showing orientation to turbine

Clearly it is best to avoid the problem in the first place by attention to careful siting. Wind turbines close to habitations, eg. ten diameters distance should not be sited to the East or South East, or West or South West of habitations, unless the shadow path has been identified and does not fall on windows of habitations or occupied buildings. Verkuijlen and Westra published useful diagrams showing maximum shadow duration contours, shadow tracks and maximum duration curves. Two other alternatives are that the turbine is stopped by a device such as the one described, or that it is sited well beyond the normal separation distance of ten diameters, as the shadow will then no longer be in sharp focus. This distance has not yet been identified.

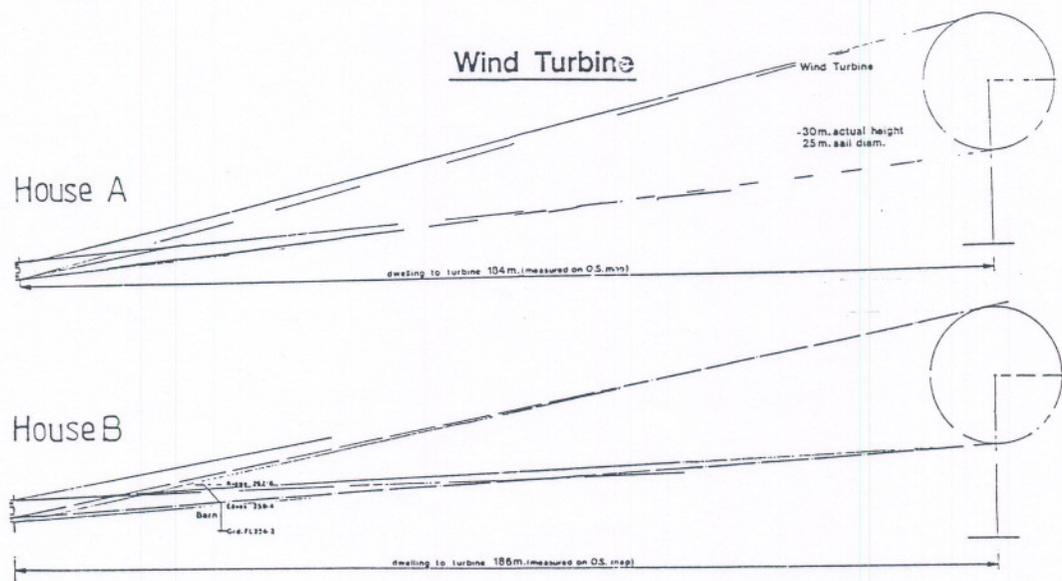
The range of angle of elevation from house B to turbine blades was 2.7-11.6 degrees.

Fig 2 Diagram showing angles of elevation from each house to turbine

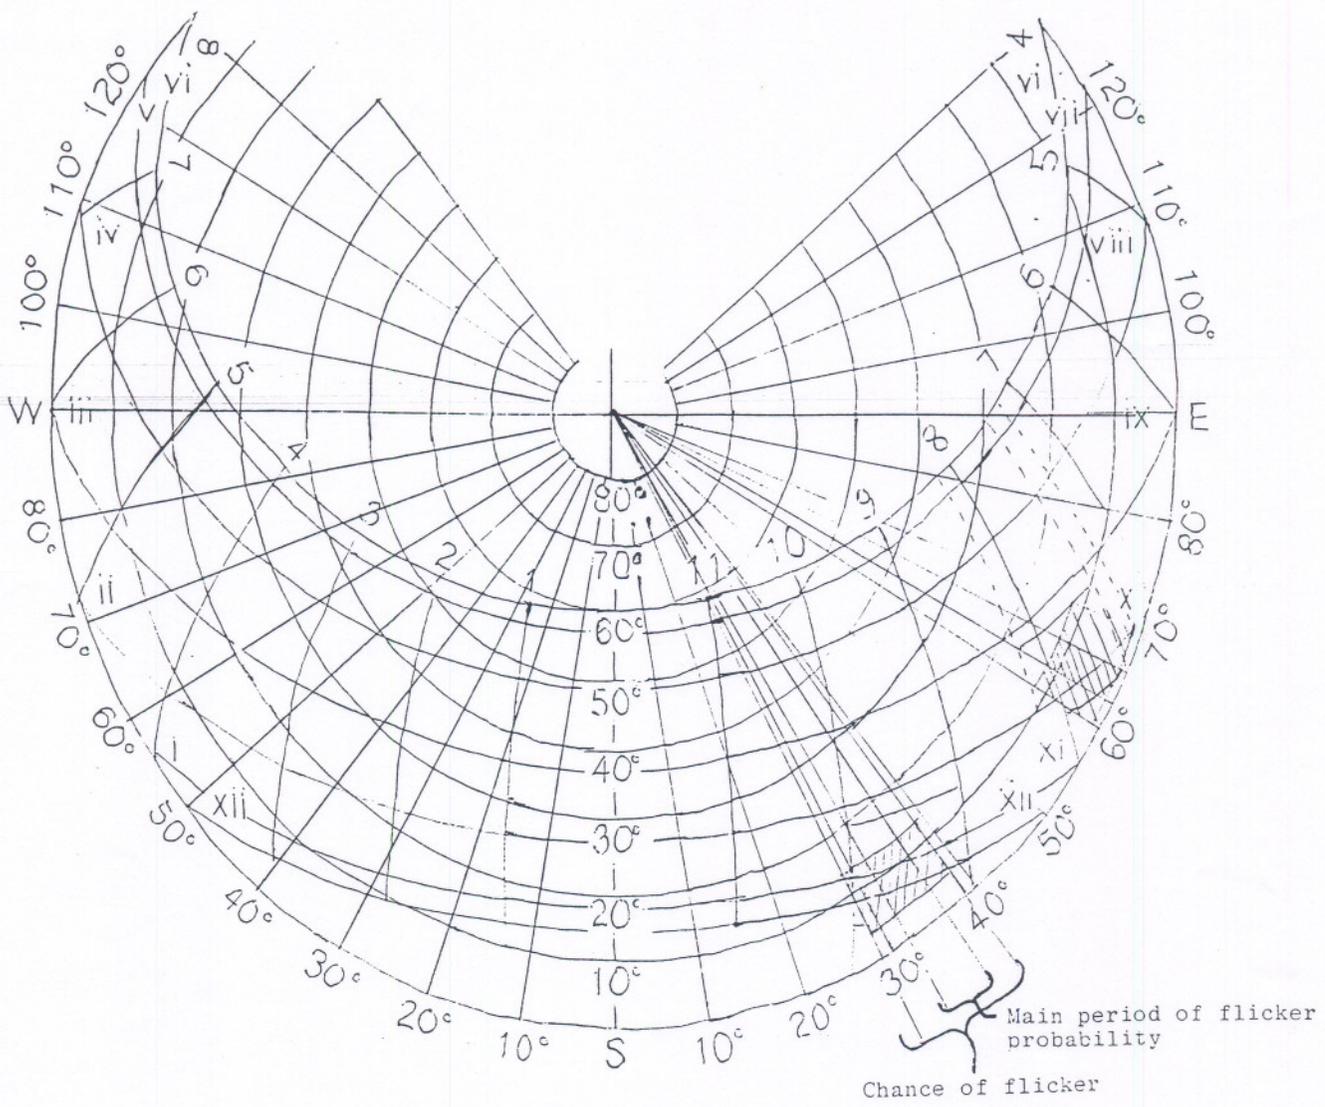
From the sunpath diagram adjusted for the latitude, the sun's path is at 142-154 degrees SE from house A and between 5.2 and 13.9 degrees elevation in the second half of November, December and early half of January, between the hours of 09-10 and 10-05 am, depending on the exact time of the year.

Therefore flicker was predicted to occur for a period of not more than about 20 minutes between these times but mainly between 09-20 and 09-50 am between Nov. 15 and Jan 15, at house A.

For house B the sun's path is at 112-123 degrees ESE and between 2.7-11.6 degrees elevation in the months of October (later 2/3rds approx.) and November, first week and January (last week) and February (first two and a half weeks), between the hours of 07-10 and 08-50 am depending on the exact time of the year.

Flicker was therefore predicted to occur for a period of not more than 20 minutes between these times, but mainly between 07-20 and 07-55 am in October after the 10th, through to approx. November 8th and also in the last two weeks of January and first two and a half weeks of February, at house B.

Fig 3 Example of part of the sun path diagram. The shaded area shows the duration and frequency of shadow flicker period

It was recommended that a timer plus photo cell should be employed to automatically switch off the turbine for the duration of the flicker period, which will not be more than about 20 minutes, if the sun is shining and the wind blowing.
